The Lost Water of Astley Castle Moat

Astley Castle,
Near Nuneaton,
Warwickshire.
52° 30′ N 1° 32½′ E
O.S. Grid Reference
SP312894

Introduction

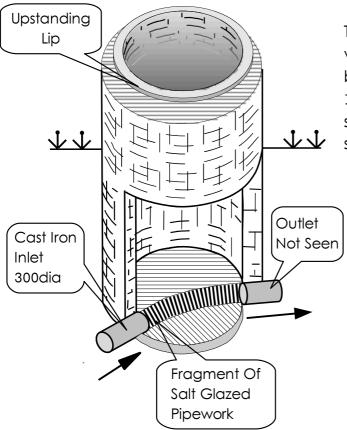
Item 5. The Overflow(?).

This brick shaft, or possibly one very close by, was first identified by the O.S. as an overflow in 1913. However what can be seen today is almost certainly something else.

Close by is a near semi – circular stone flag and at least one large fragment of another flagstone. These flagstones have not been lifted but if they were, and found to have a recess matching the raised lip on the sill, the evidence for the shaft being covered, and therefore not being an overflow, would be very convincing.

The shaft gives access to a sewer that flowing from item 6a turns to run northwards generally parallel to the moat at this point. The base of the shaft is concrete. It is moulded on two levels so as to provide an easy sweep bend for the sewage flow. A fragment of salt glazed pipe seen at the inlet might indicate that such pipework might have been used to form the bend at some time. Indeed the concrete might well postdate construction of the shaft.

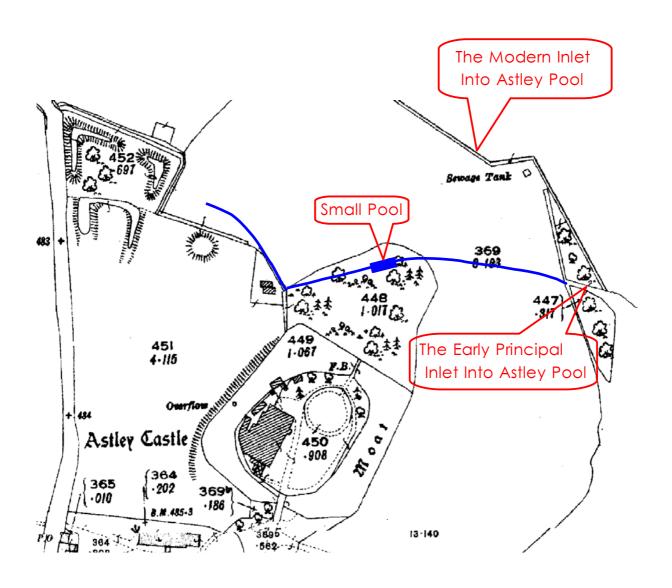
Map 1. Early Water Features, from 1807, superimposed onto the OS 1913 1:2500 Map

Clearly the Castle Grounds have changed greatly since earlier times and to see more clearly those changes I have added the early water features onto the 1913 map (Map 1). Clearly the principal feeder into Astley Pool has changed. In early days this came from a Small Pool just north of the Castle Moat. Now the principal feeder is from from a steam further to the north – the stream that passes the sewage tank. The old estate plans probably show another stream running west from the Small Pool and leading away towards where now are the Fish Ponds with a branch to the Moat. All of this is now lost, or dry, and it is uncertain which way the water would have flowed i.e. into or out of the Small Pond. The Fish Ponds and Mound first appear in 1888 – the Sewage Tank appears in 1903 whilst the buildings just to the north east of the Moat and the overflow first appear in 1913.

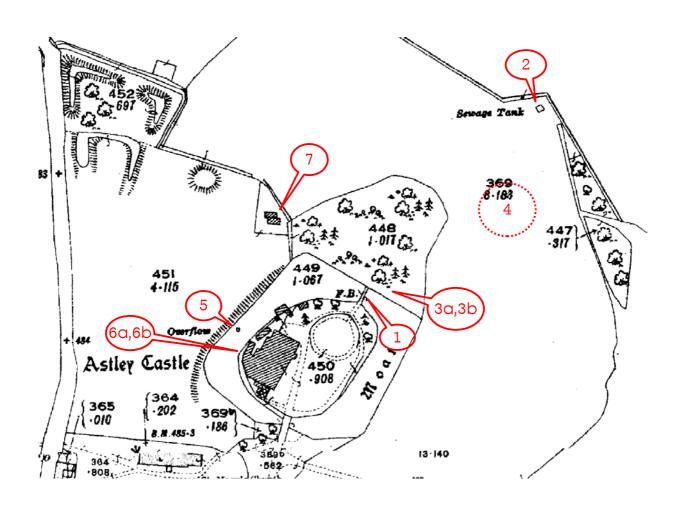
Map 2. Location of Features Identified in the Text.

- 1. The Old Footbridge
- 2. The Sewage Tank
- 3. Two Shafts
- 4. Heavy Wooden Cover
- 5. A Shaft (The Overflow?)
- 6. A Shaft and a Brick Chamber
- 7. A Shaft and Building Foundations.
